REPORT NO. 327/2

RIFLE BARREL STEEL - SPRINGFIELD ARMORY

WATERTOWN ARSENAL
WATERTOWN, MASS.

SUMMARY OF INVESTIGATION OF RIFLE BARREL STEEL

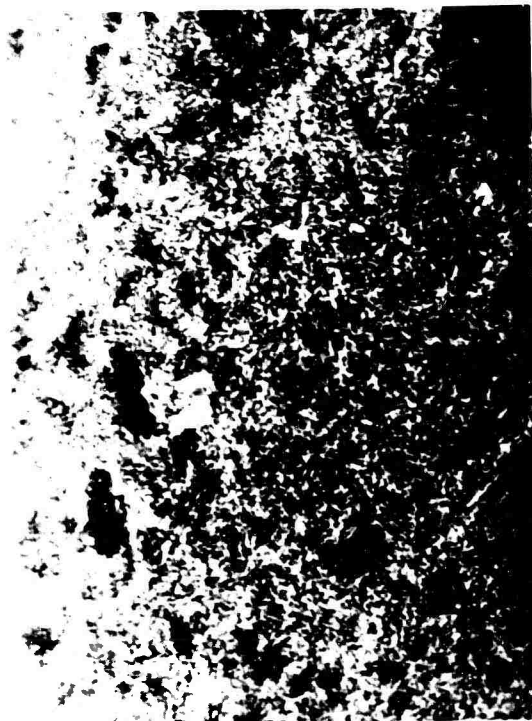
W.A. 639-702

Figs. 3 & 4, X100 1% Nital etched, FNA, Midwall and bore sections. The structure was fairly fine grained but segregated. Bore section was somewhat higher in carbon than the midwall.
MG-259 & 260

Figs. 5 & 6, X1000, Same as Figs. 3 & 4. The structure was in a hot worked condition.
MG-269 & 270
Plate WA639-702

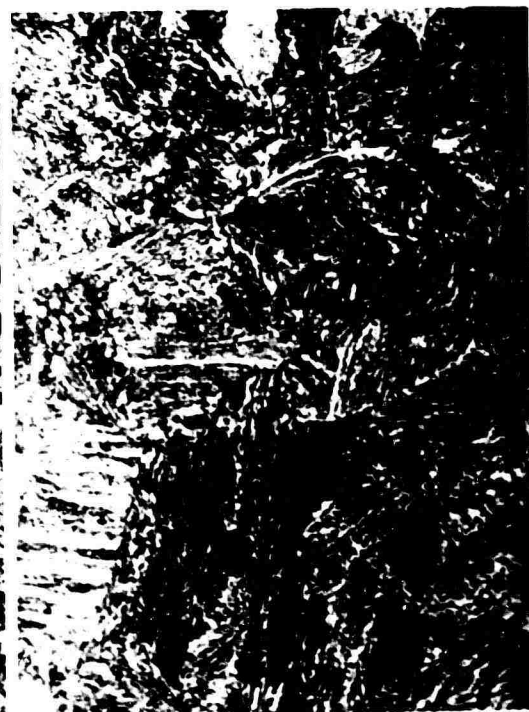
W.A. 639-704

Fig. 11, X25, Unetched, M1A. Moderately dirty. Small, short inclusions with a tendency to form chains, however, only a few chains actually formed.
MG-280

Fig. 12, X3, CuCl_2 etched, M1A. Steel was banded.
MG-281

Figs. 13 & 14, X100 & X1000 1% Nital etched. M1A. Somewhat segregated, grain size #6, Hot worked condition.
MG-262 & 272

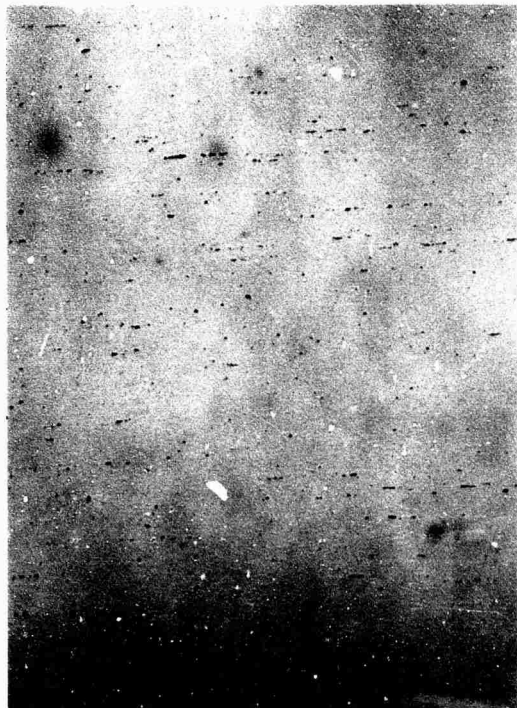
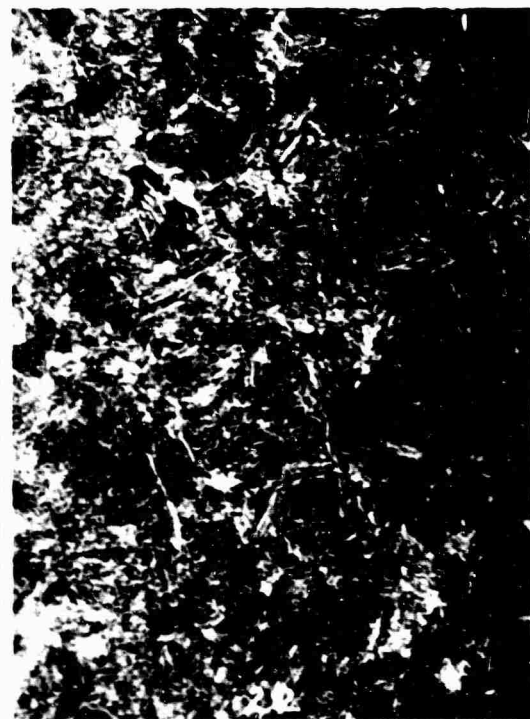
W.A. 639-706

Fig. 19, X25, Unetched C2A. Fairly clean. Inclusions
small, more or less separated short
chains. MG-284

Fig. 20, X3, CuCl_2 etched, C2A. The steel was decidedly
banded. MG-285

Figs. 21 & 22, X100 & X1000, 1% Nital etched, C2A.
Slightly segregated fine grained
troostite sorbite with some free
ferrite.

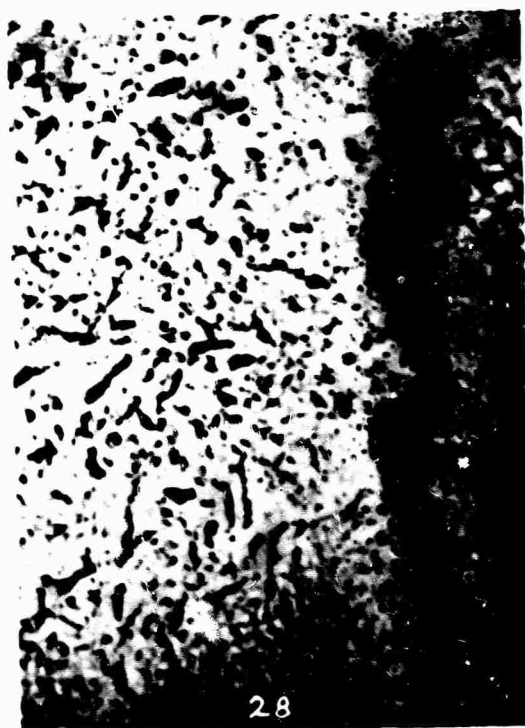
WA 639-708

Fig. 26, X25, Unetched, Long. Sect. AVA. Steel is dirty.
Inclusions were fairly small with a tendency to form chains. MG-286

Fig. 27, X3, CuCl_2 etched, AVA. Steel is banded. MG-287

Fig. 28, X25, CuCl_2 etched, AVA. Crack area. Badly segregated & burnt.
A - phosphorus segregates
B - ferrite segregates
Indicates insipient fusion - i.e. Burnt metal MG-266

Fig. 29, X25, CuCl_2 etched AVA. Area opposite crack. Condition similar to Fig. 28. MG-267

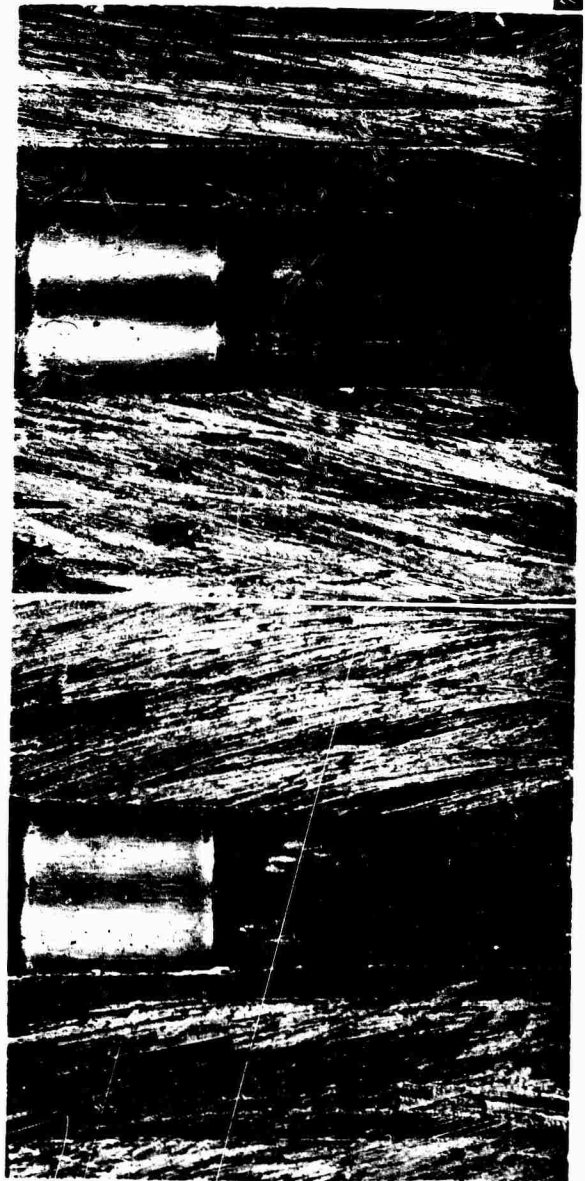
FIG. I

The condition of the bore is shown in Figure 1. The lands were eroded smooth with grooves; checking and spalling were noticeable. Figure 2 shows the extent of cracking at a cross-section of the bore. Figures 3 and 4 show the intersections of radial cracks with non-metallics strung out normal to them.

Both Halves of Colt Machine Gun Barrel A
(X.O. 47-A19) X3.

Section at origin of rifling.

Fired 10,000 rounds.

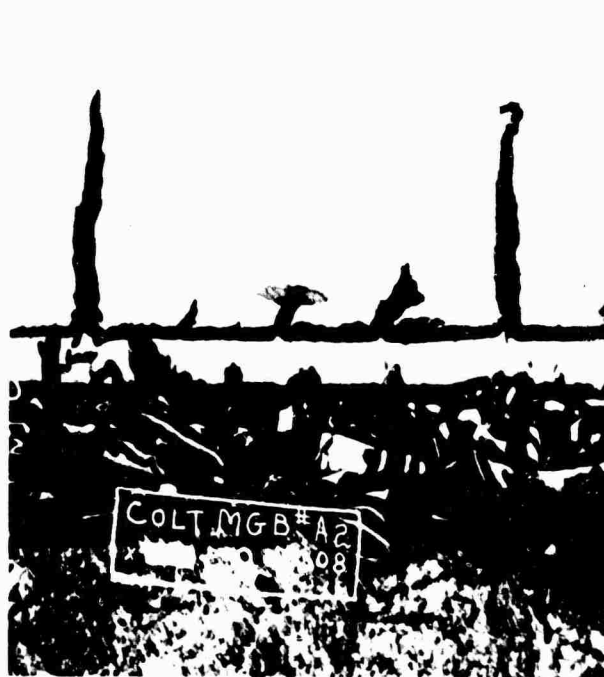
Fig.3

most, but not all, branches seem to be parallel to bands and to bore. The intersection of radial cracks with nonmetallics may be a point of weakness facilitating the origin of a longitudinal crack.
